MAIN ISSUES OF IMPROVING THE SEISMIC RESISTANCE OF BUILDINGS

Abstract: *The article analyzes the terrible earthquake that occurred in Turkey in 2023 and its consequences, as well as the causes of damaged buildings from a structural point of view. It also provides information about the location of tectonic plates in the country and their movements. The article contains opinions on measures to prevent the repetition of the mistakes made in the reconstruction of buildings destroyed by the earthquake in Turkey and measures to protect the population from seismic hazards.*

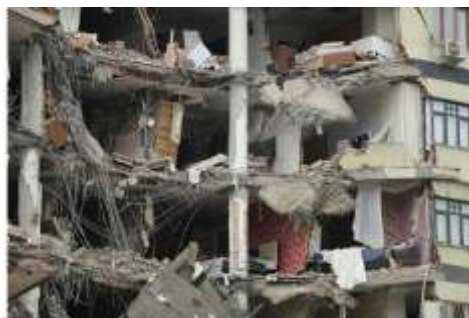
A system built directly on columns was used. In seismic conditions of 9 points, this system is generally an unacceptable structural solution. In particular, in the buildings built as open-air shops on the first flexible floor, it can be seen that there are no walls that can absorb the loads from the second and upper floors. It is natural for the buildings built on the basis of such a system to collapse (Fig. 3).

Figure 3. A building built on the basis of a beamless system.

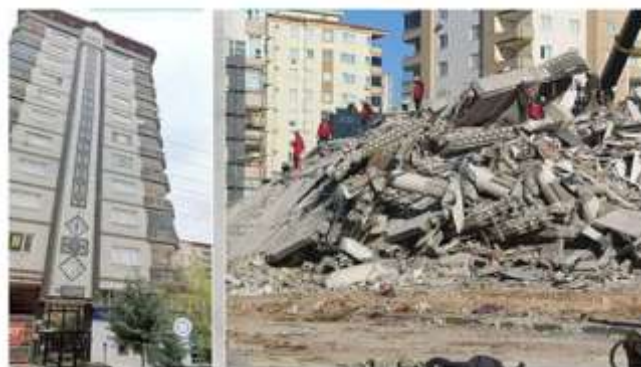
Figure 4. Before and after: A recently built house in Iskandar.

As you can see from the photos, the houses, which were destroyed to the foundation, built without specific regulatory requirements, testify to the presence of serious deficiencies in the load-bearing columns.

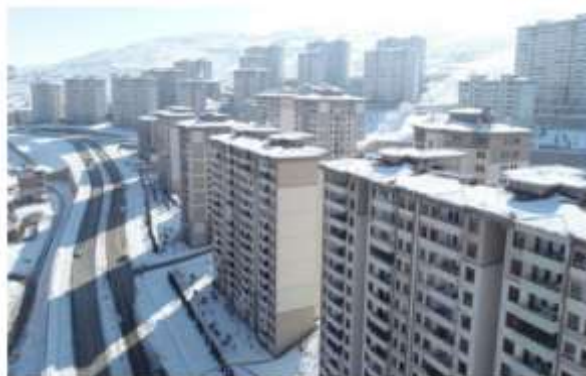
According to experts, in a number of cases in Turkey, without supporting beams, the analysis shows that none of the buildings built by the Turkish Housing Authority (TUJB) collapsed. It turned out that none of the 133 thousand 759 houses built by this organization located in the earthquake area were even damaged (Figure 5).

Figure 5. Buildings built by the Turkish Housing Authority

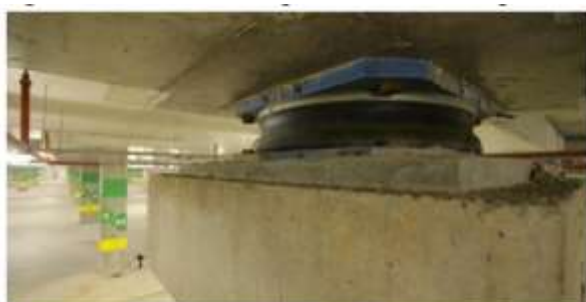
All the buildings built by TUJB remained usable after the earthquake. Because the buildings built by TUJB were built on an earthquake-resistant seismic protective foundation, and the entire load-bearing system was built on this device (Fig. 6).

Figure 6. A building installed using seismic isolators.

When using this structural system, buildings do not collapse during an earthquake. It is certain that this building will not be damaged if construction work is carried out by qualified construction engineers based on adequate structural requirements that are suitable for seismic areas. In particular, in this case, during an earthquake, the supporting structures inside the buildings may be damaged, but no buildings will collapse.

Thanks to the seismic isolators installed in the floors of the maternity hospital and the children's hospital, the buildings withstood the earthquake without any damage.
